# FACILITY COMPLIANCE INSPECTION REPORT

## Division of Waste Management Solid Waste Section

**Date of Site Inspection:** 2/7/2012

Myers Place  
 Myers Road  
 Granite Falls, NC 28630

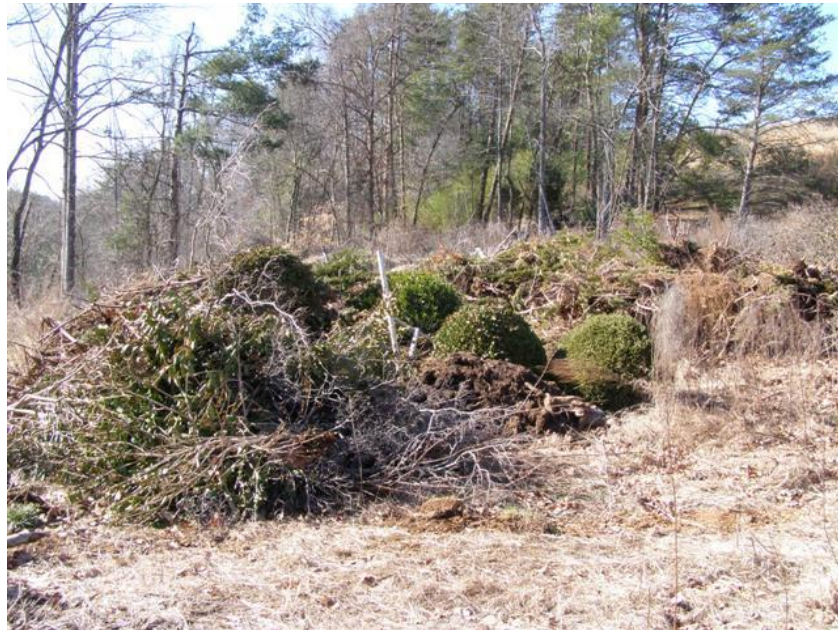
View of recently deposited LCD at the top of the landfill with a piece of PVC pipe.  
Digital image taken by Deb Aja on 2/7/2012.

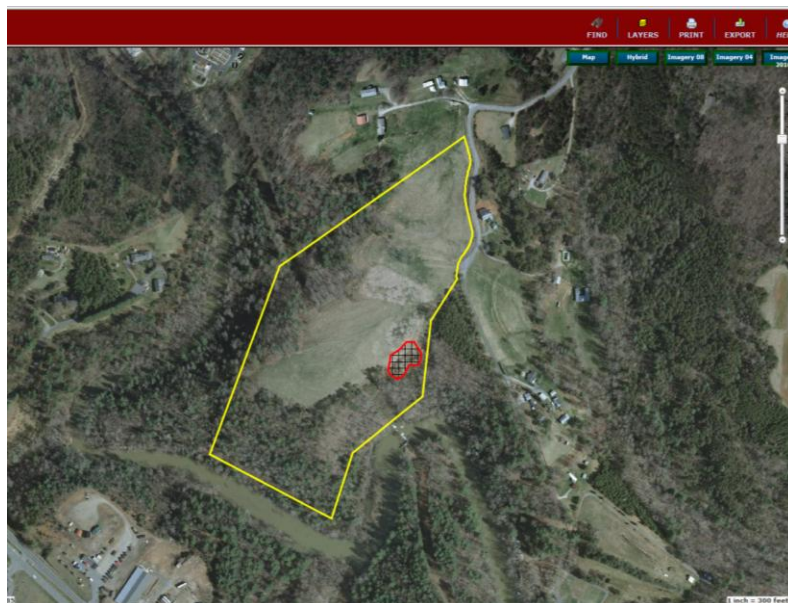
Figure 2: Approximate landfill location (red outline) and  
Property Line location (yellow outline, Caldwell County GIS).

4. The facility must maintain the following setbacks pursuant to 15A NCAC 13B .0564(9): (a) 50 feet from the waste boundary to all surface waters of the state as defined in G.S. 143-212, and, (b) 100 feet from the disposal area to property lines, residential dwellings, commercial or public buildings, and wells. **It appears that the edge of waste may be closer than 100 feet to the property line on the east side of the landfill after a review of aerial photographs and Caldwell County GIS records (see Figure 2).** Field measurements could not be obtained as the waste disposal area was very steep and property lines were not marked. Property lines should be marked and so that the distance between the edge of waste and the property line can be measured to ensure compliance with the required setbacks. **A follow up inspection will be conducted to determine if the facility is in compliance with the setbacks. Any waste within the 100' setback must be removed or property lines adjusted to achieve compliance with 15A NCAC 13B.**

5. In reviewing aerial photographs and Caldwell County GIS records it appeared that the waste disposal area was a distance of approximately 200 feet from Gunpowder Creek.

6. In reviewing aerial photographs and Caldwell County GIS records it appeared that the waste disposal area was approximately one-half acre in size.
7. The top of the waste disposal area was partially covered with soil. The land clearing waste was uncovered at the outer edges and at the steep (nearly vertical) side slopes of the disposal area. It was stated that the exposed waste observed had been deposited more than one month prior to the and that the exposed waste was deposited over a period of years. The area of uncovered waste was approximately one-half an acre in size. Operational requirement 15A NCAC 13B .0566(4) requires that "Adequate soil cover shall be applied monthly, or when the active area reaches one acre in size, whichever occurs first." **Adequate cover means the entire landfill, including the working face, shall be covered. Proper operating practices at LCID landfills are extremely important in the prevention of fires and the protection of public health and the environment. Landfill fires are often very difficult to extinguish and are usually the result of improper operating practices.**

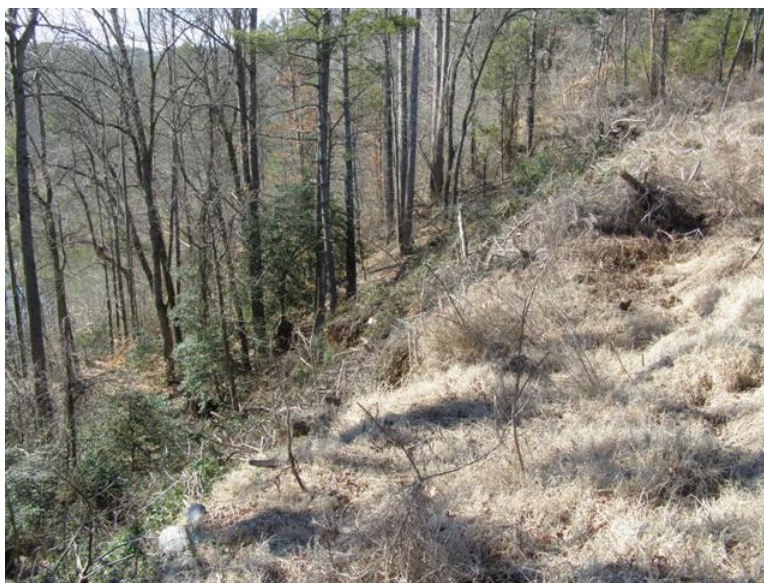
On February 7, 2012, waste was observed without soil cover in the landfill. The land clearing waste was uncovered at the outer edges and at the steep (nearly vertical) side slopes of the disposal area. It was stated that the exposed waste observed had been deposited more than one month prior to the inspection and that the exposed waste was deposited over a period of years. The area of uncovered waste was approximately one-half an acre in size. This constitutes a violation of 15A NCAC 13B .566(4).

View of nearly vertical landfill side slope with uncovered waste.  
Digital image taken by Deb Aja on 2/7/2012.

**To correct this violation and be in compliance with 15A NCAC 13B .566(4), by June 15, 2012, you must place adequate soil cover over all waste in the landfill. Prior to placing the soil cover the waste must be compacted and shaped to allow surface water to runoff in a controlled manner. For proper closure of the landfill one foot of soil cover must be placed over the waste. Adequate erosion control measures, structures, or devices shall be utilized to prevent silt from leaving the site and to prevent excessive on site erosion. Ground cover sufficient to restrain erosion must be established over the soil cover.**
